EXHIBIT 7

July 26, 2019

As you requested, this is a letter report on the vegetation management field inspections ("VM inspections") the Monitor team is conducting pursuant to the Court's April 3, 2019 Order ("April 3 Order"). This submission includes: (1) background information on the VM inspections; (2) an explanation of the VM inspections process; (3) the Monitor team's preliminary observations; (4) PG&E's feedback based on the Monitor team's preliminary findings; (5) the Monitor team's preliminary suggestions to PG&E, as shared with the Company on July 17, 2019; and (6) concluding thoughts.

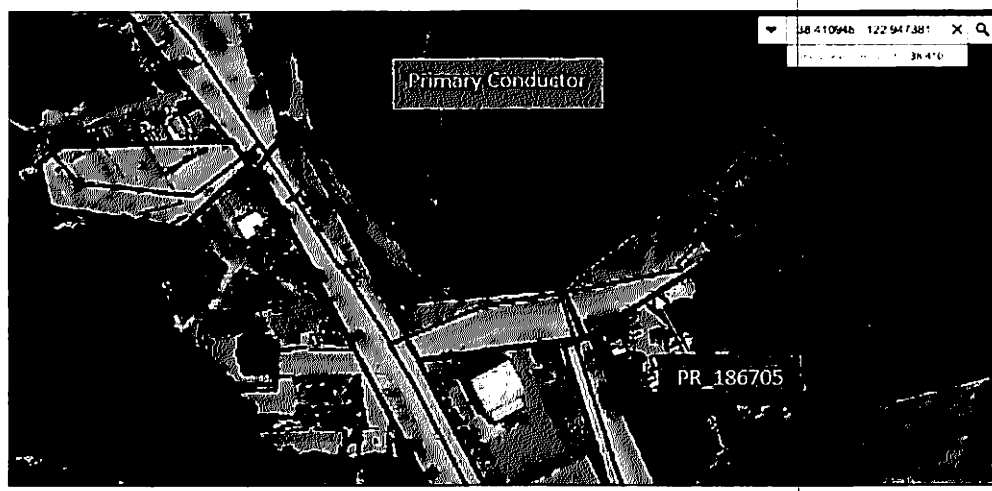
A potential hazard tree was found during a Monitor Inspection on June 18, 2019 of Project *PR_186705* on Circuit *Molino 1102*. In general terms, this circuit is located on the outskirts of the city of Sebastopol, CA, running approximately 10 miles to the west of the city. This circuit is located in/near a Tier 3 fire threat area pursuant to the ArcCollector database. The approximate position of the tree is denoted as the red circle in the second graphic below.

Figure 6: Excerpts of the first page of a sample potential exception report, reflecting the project location and description.

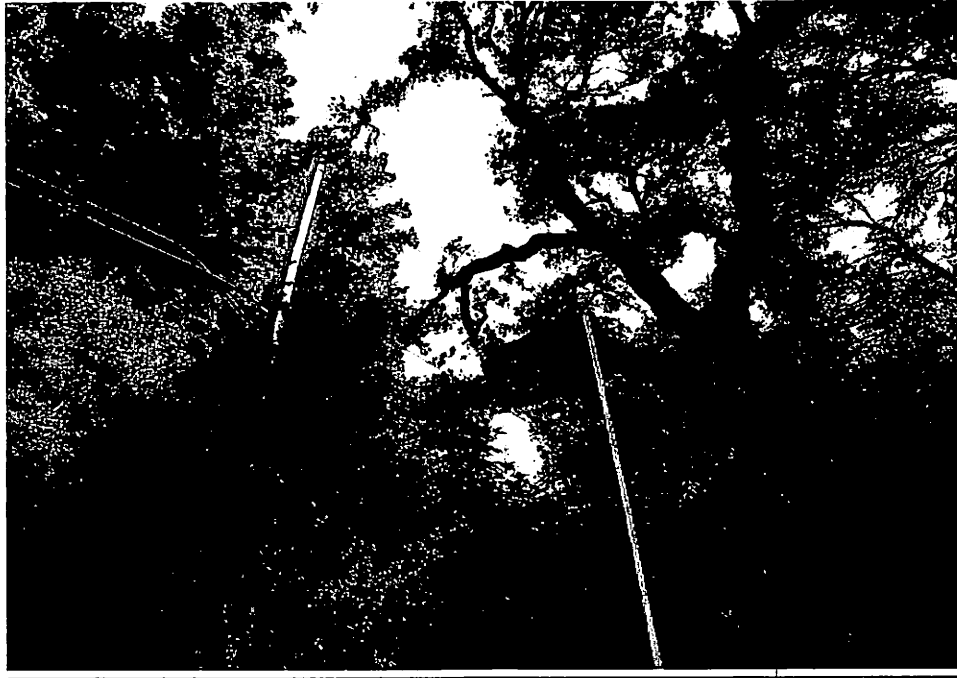
PG&E ArcCollector Project Status	No Work Required Under EVM	
Monitor Team Observed Tree Work in Immediate Vicinity of Subject Tree	Yes	
Species	Coastal Live Oak	
GPS Coordinates	38.410948, -122.947381	
Approx. Distance from Primary Conductor	Trunk of tree 23 feet south	
Approx. Height	56 feet	
Veg Type	Potential Hazard Tree	
Monitor Arborist Comment	Observations of the tree include (a) cavity in trunk displays evidence of decay. (b) guy wire embedded in trunk, and (c) tree leaning toward primary conductor

Figure 8: Photos included in a sample report. Here, the photos substantiate the observations that (1) there is a cavity in the trunk, (2) the tree is leaning towards the primary conductor, and (3) guy wire is embedded in the tree's trunk.

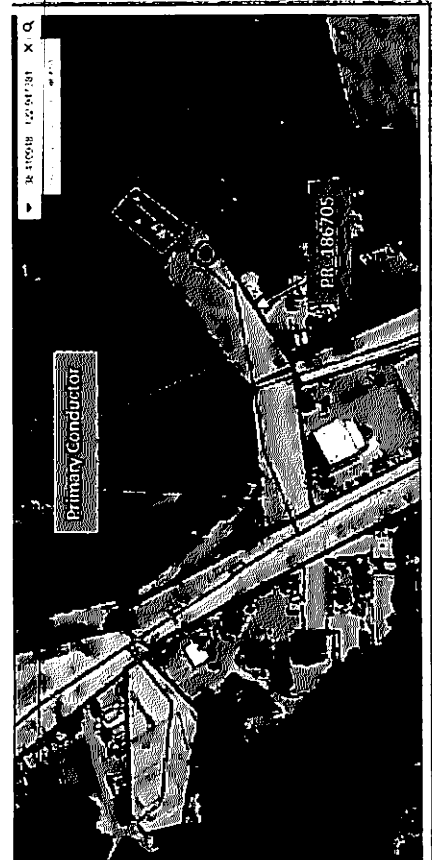
PG&E ArcCollector Project Status	No Work Required Under EVM
Monitor Team Observed Tree Work in Immediate Vicinity of Subject Tree	Yes
Species	Coastal Live Oak
GPS Coordinates	38.410948, -122.947381
Approx. Distance from Primary-Conductor	Trunk of tree 23 feet south
Approx. Height	56 feet
Veg Type	Potential Hazard Tree
Monitor Arborist Comment	Observations of the tree include (a) cavity in trunk displays evidence of decay, (b) guy wire embedded in trunk, and (c) tree leaning toward primary conductor

Photographs below show subject tree and proximity to the primary conductor.

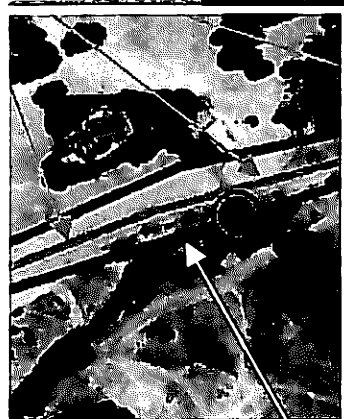
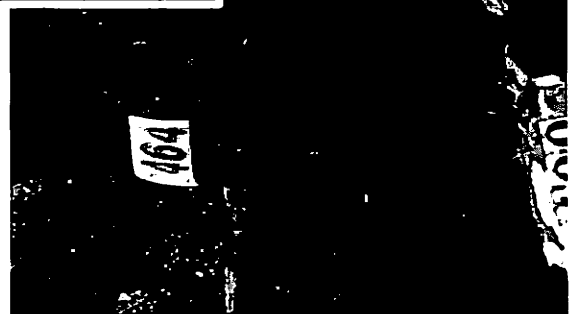
- The Monitor team has often observed trees that were marked with tree paint by a pre-inspector but were not entered into Arc Collector (*left example below*). The Monitor team has also observed the inverse issue, where the tree was included in Arc Collector but not marked with paint or flagging (*right example below: confirmed that stake in photo is not associated with tree work*).

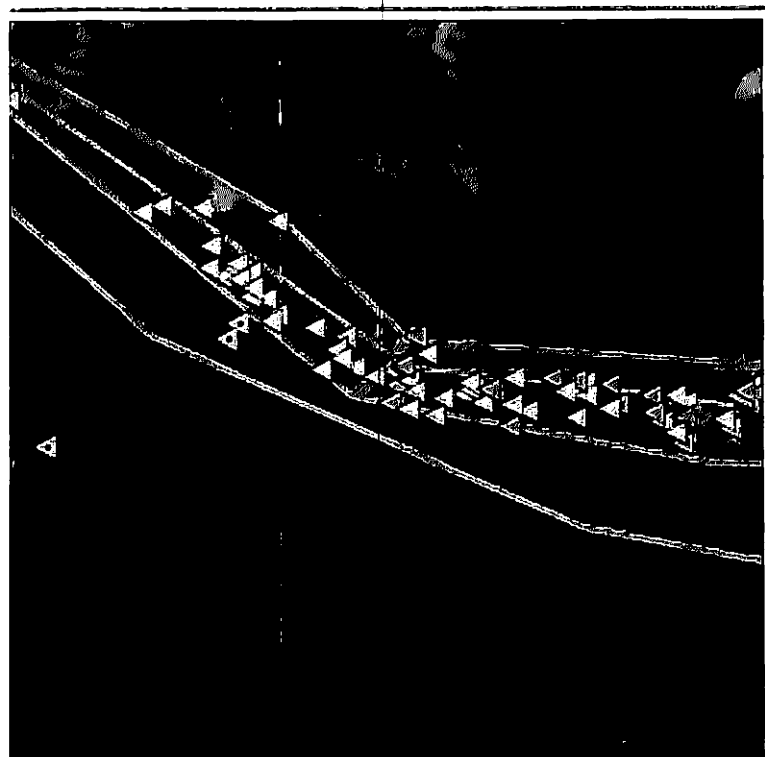
- Re-inspection after post-work verification is not recorded consistently. The Monitor team observed that inspectors came to an area and marked trees that needed to be remediated with yellow paint, but only added some of those trees into Arc Collector (*left photo, dark green triangles*). In other areas, pre-inspectors appeared to have re-inspected an area, with paint on trees needing remediation, but they made no additions on Arc Collector (*right photo*).

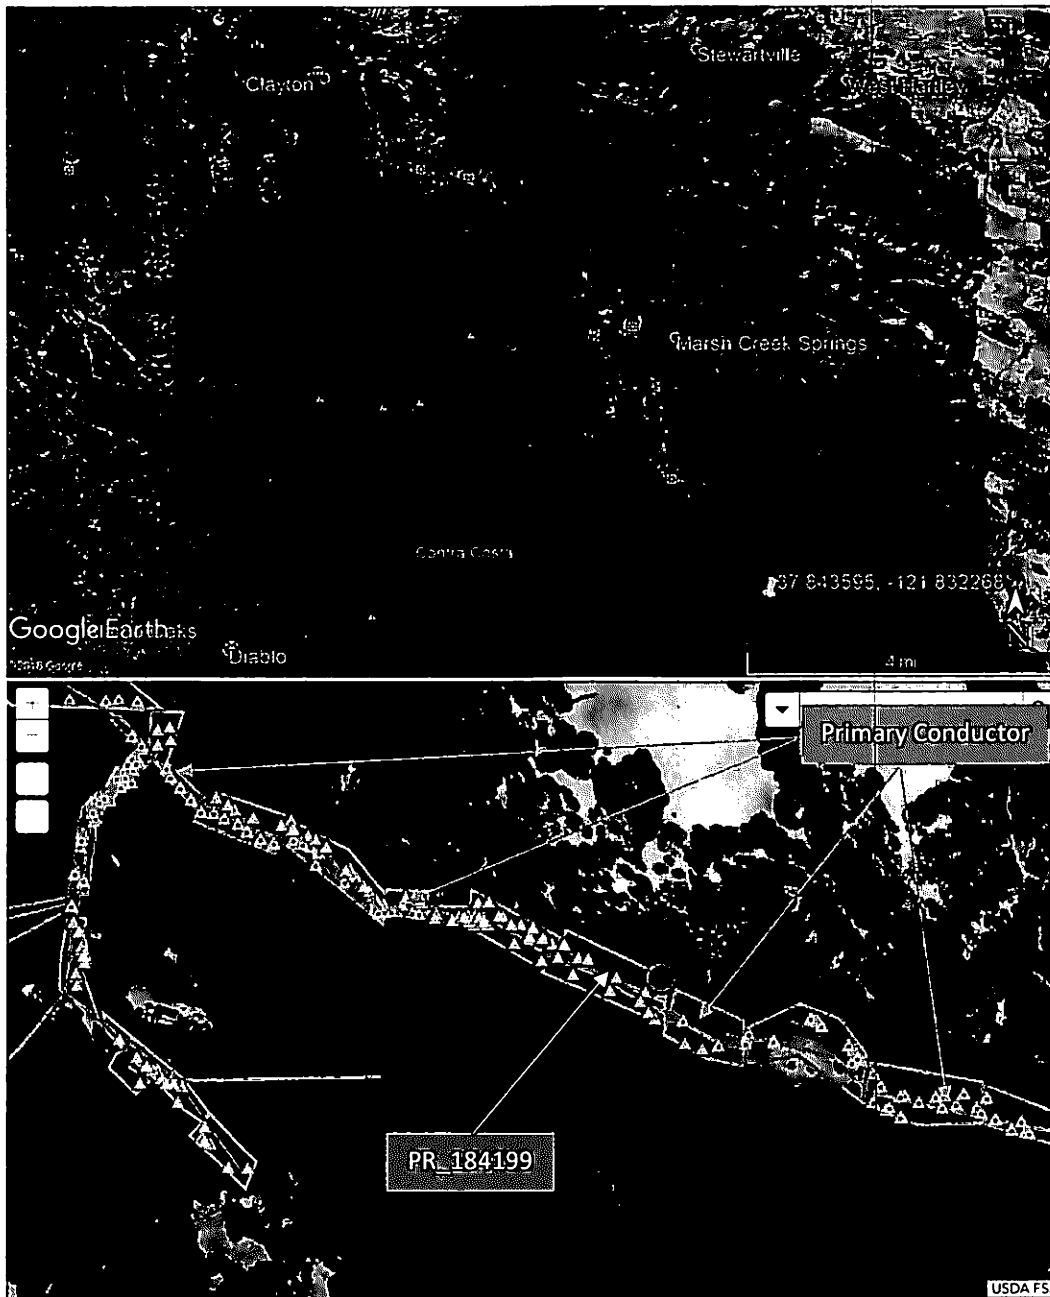
A potential hazard tree was found during a Monitor Inspection on June 7, 2019 of Project *PR_184199* on Circuit *Clayton* 2212. In general terms, this circuit is located on the outskirts of the town of Clayton, CA, running approximately 15 miles to the southeast of town. This circuit is located in/near a Tier 3 fire threat area pursuant to the ArcCollector database. The approximate position of the tree is denoted as the red circle in the second graphic below.

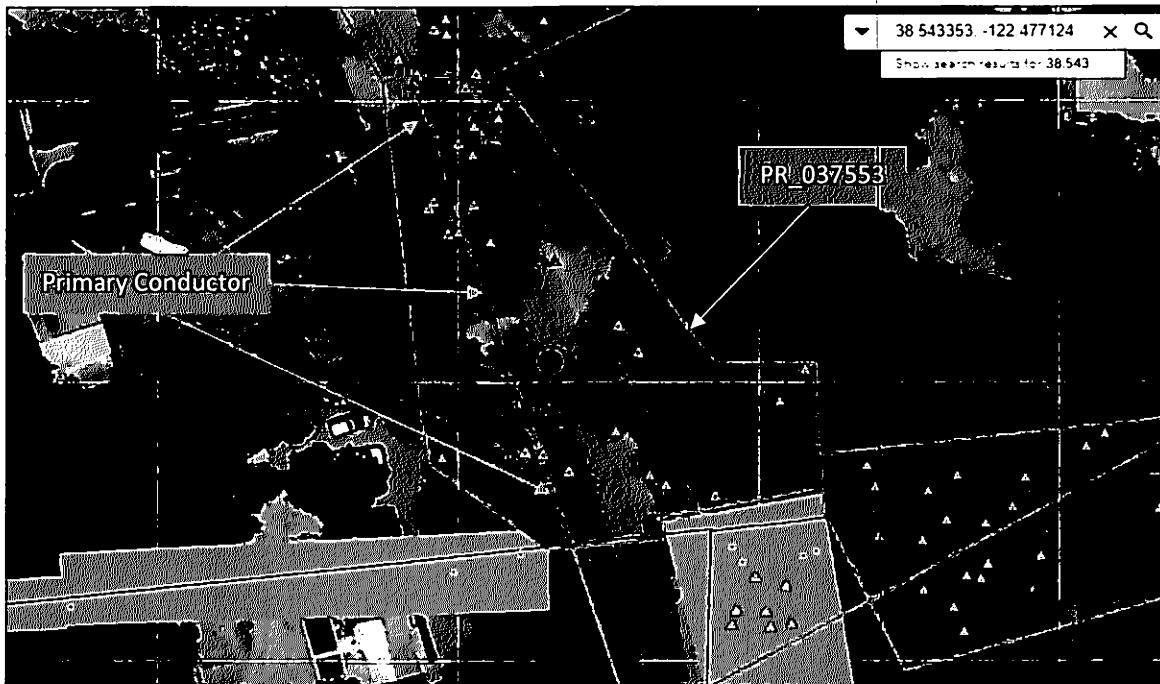
A potential hazard tree was found during a Monitor Inspection on July 9, 2019 of Project *PR_037553* on Circuit *Silverado 2104*. In general terms, this circuit is located on the outskirts of the city of St. Helena, CA, running approximately 15 miles to the north of the city. This circuit is located in/near a Tier 3 fire threat area pursuant to the ArcCollector database. The approximate position of the tree is denoted as the red circle in the second graphic below.

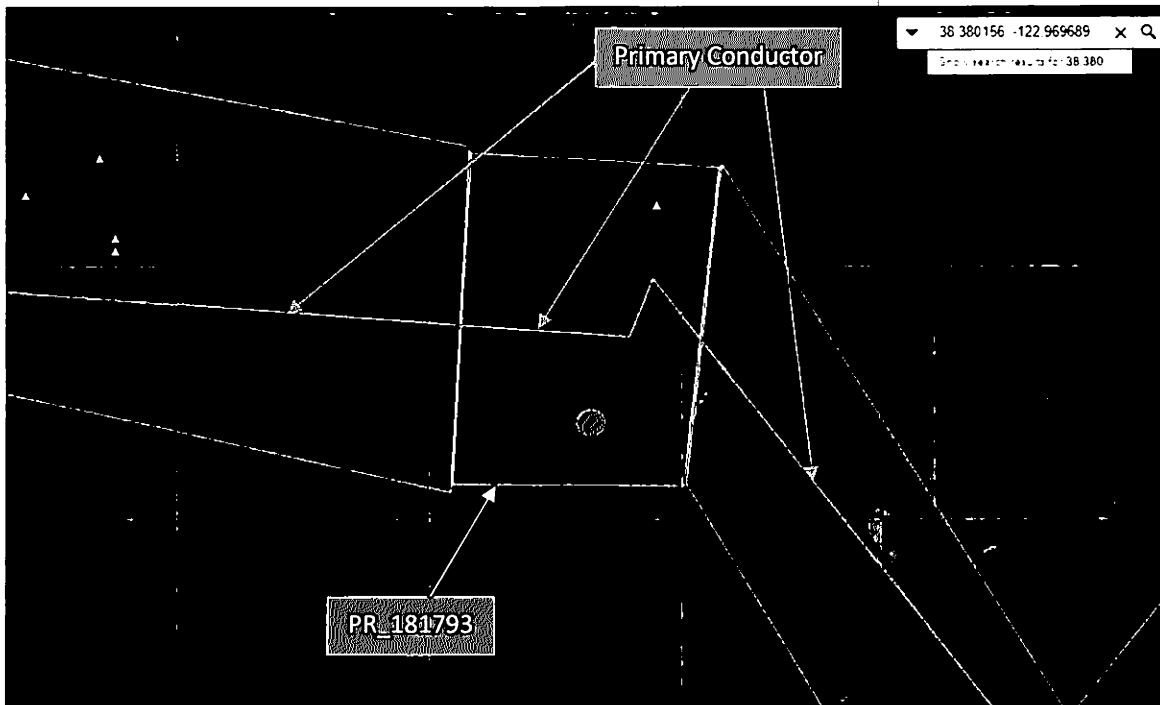
A potential hazard tree was found during a Monitor Inspection on July 10, 2019 of Project *PR_181793* on Circuit *Molino 1102*. In general terms, this circuit is located on the outskirts of the city of Sebastopol, CA, running approximately 10 miles to the west of the city. This circuit is located in/near a Tier 3 fire threat area pursuant to the ArcCollector database. The approximate position of the tree is denoted as the red circle in the second graphic below.

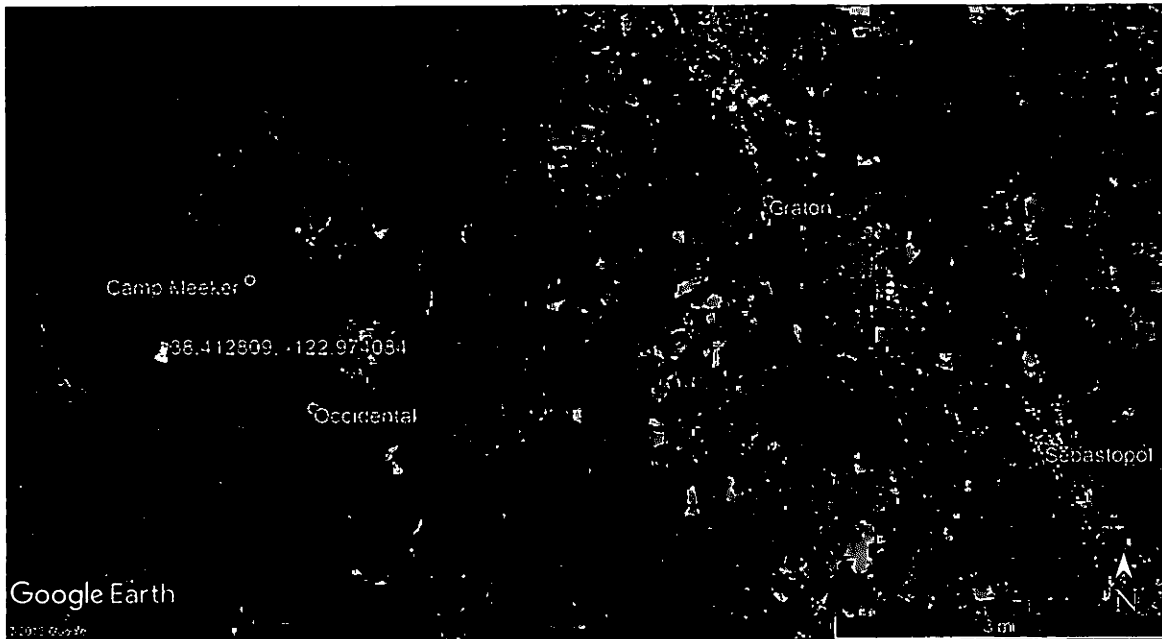
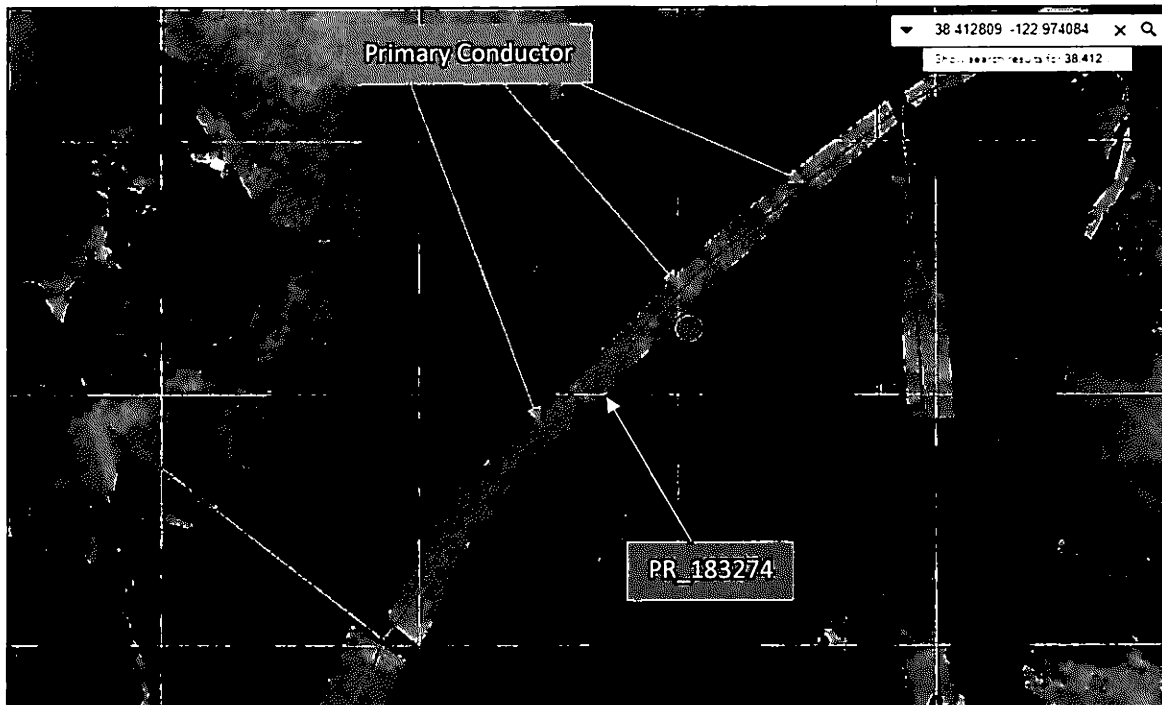
A potential hazard tree was found during a Monitor Inspection on July 8, 2019 of Project *PR_183274* on Circuit *Molino 1102*. In general terms, this circuit is located on the outskirts of the city of Sebastopol, CA, running approximately 10 miles to the west of the city. This circuit is located in/near a Tier 3 fire threat area pursuant to the ArcCollector database. The approximate position of the tree is denoted as the red circle in the second graphic below.

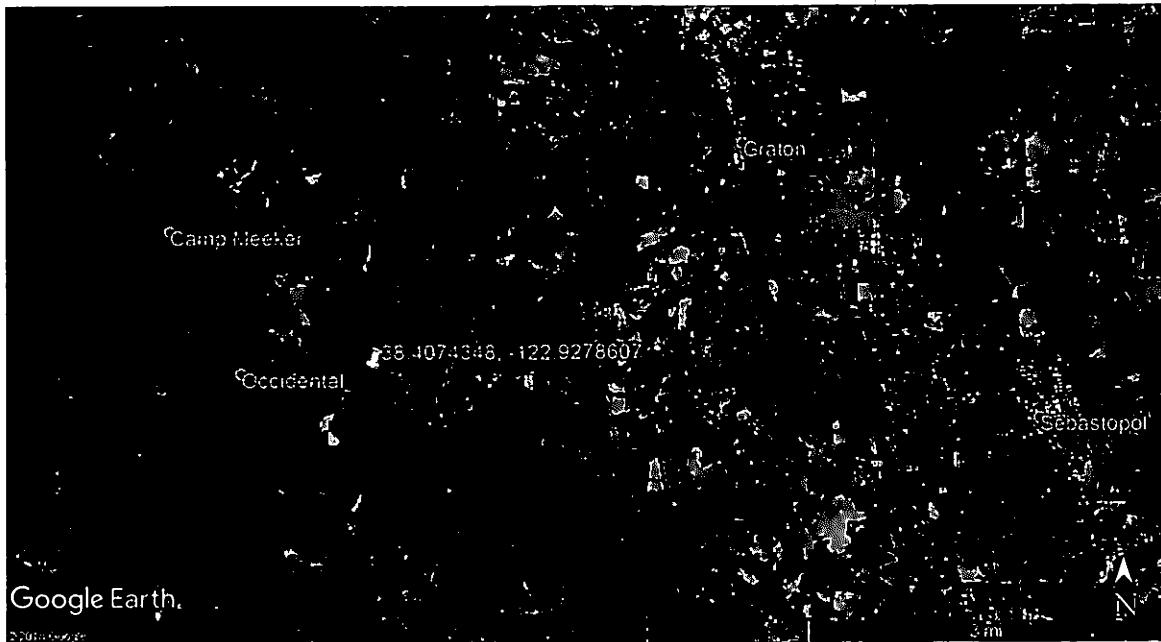
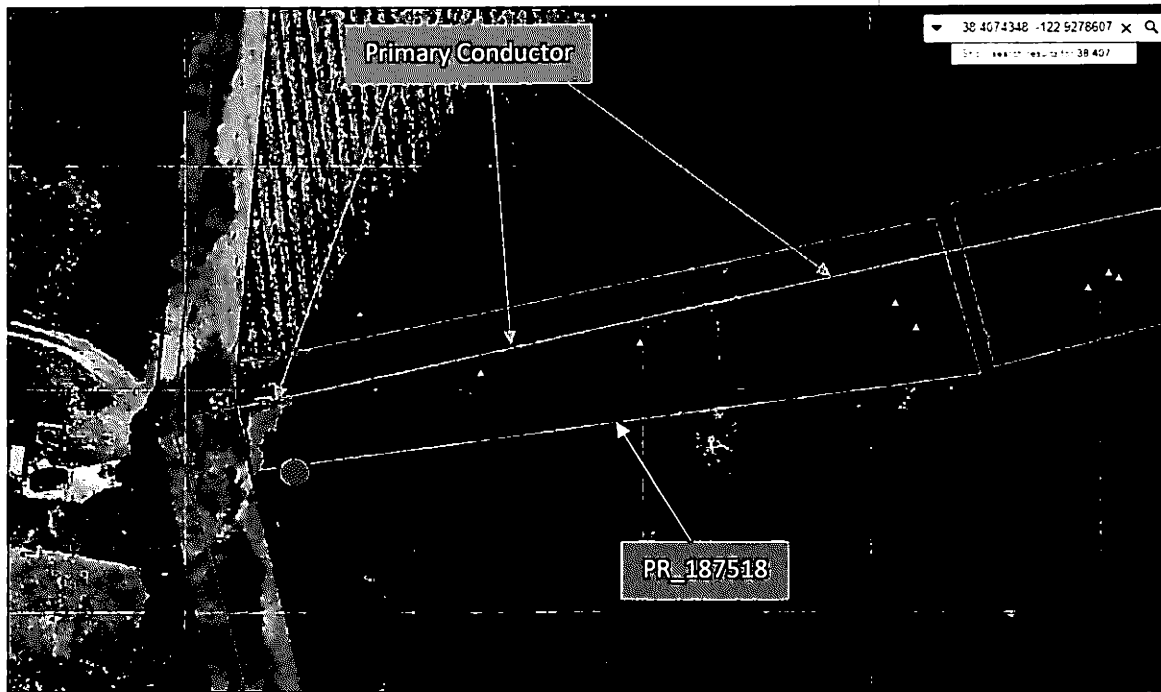
A potential hazard tree was found during a Monitor Inspection on July 8, 2019 of Project *PR_187518* on Circuit *Molino 1102*. In general terms, this circuit is located on the outskirts of the city of Sebastopol, CA, running approximately 10 miles to the west of the city. This circuit is located in/near a Tier 3 fire threat area pursuant to the ArcCollector database. The approximate position of the tree is denoted as the red circle in the second graphic below.

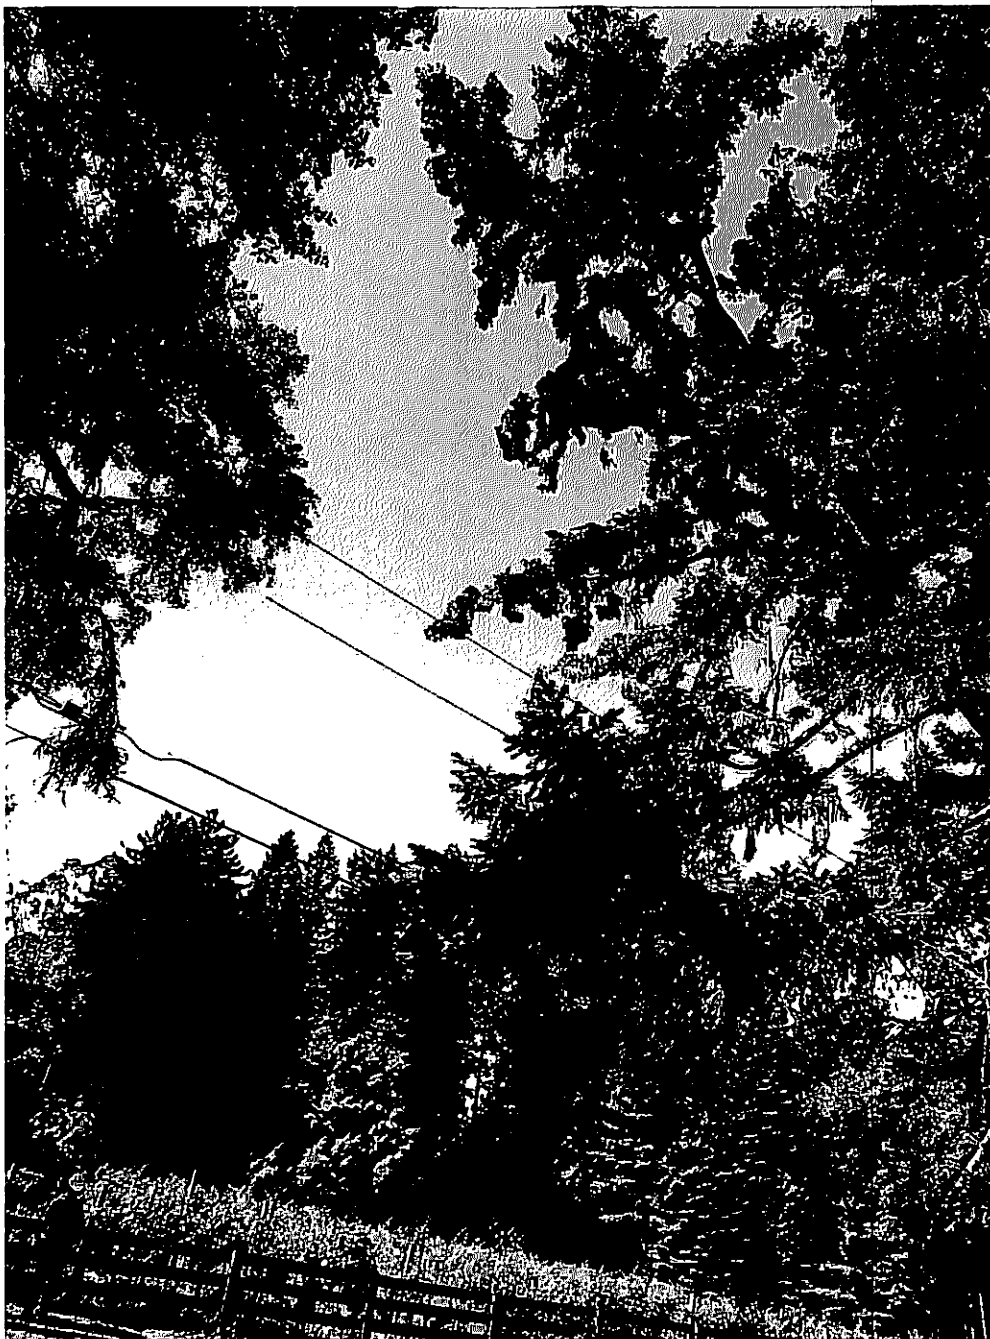
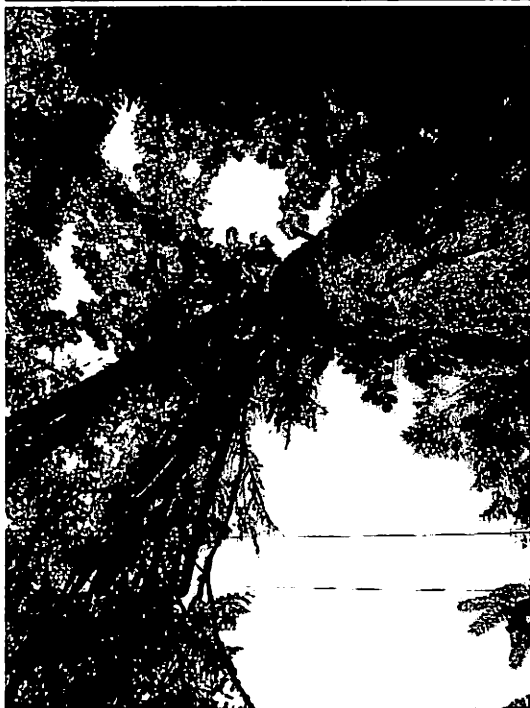
PG&E ArcCollector Project Status	Work Identified	
Monitor Team Observed Tree Work in Immediate Vicinity of Subject Tree	No	
Monitor Team Observed Recent Tree Work on Subject Tree	No	
Tree Paint or Other Markings Observed	No paint observed	
Species	Douglas Fir	
GPS Coordinates	38.4074348, -122.9278607	
Approx. Distance from Primary Conductor	Trunk of tree 50 feet southeast	
Approx. Height	100 feet	
Veg Type	Potential Hazard Tree	
Monitor Arborist Comment	Observations of the tree include (a) tree leaning 40 degrees towards the primary conductor, (b) failure would strike the primary conductor, and (c) no apparent lifting of the roots.

Photographs below show subject tree and proximity to the primary conductor.

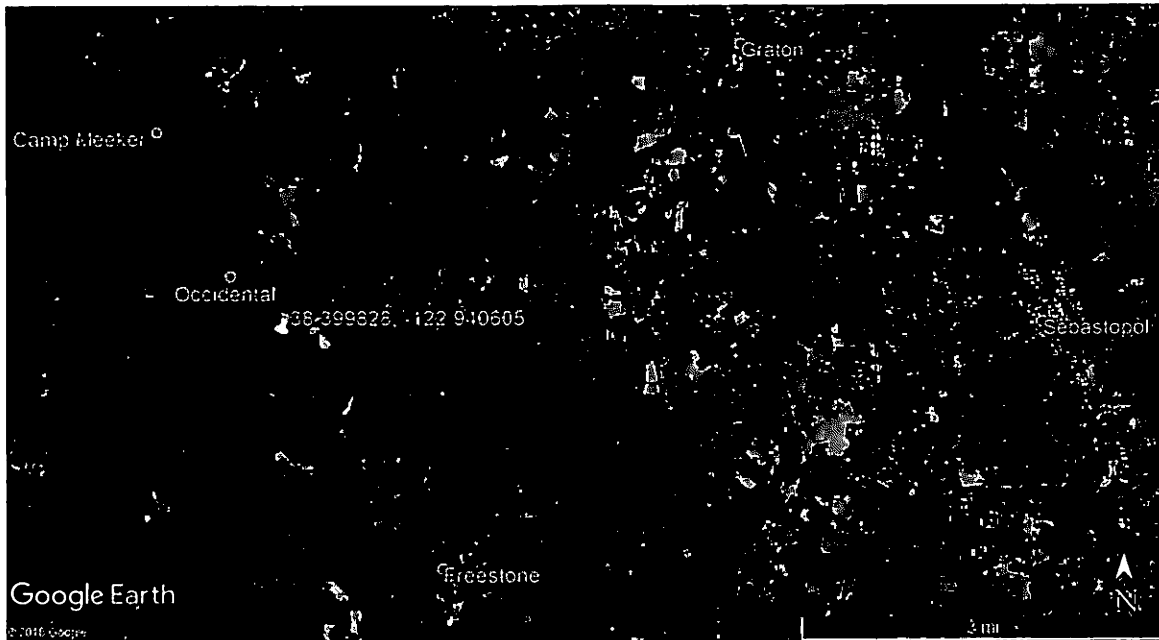
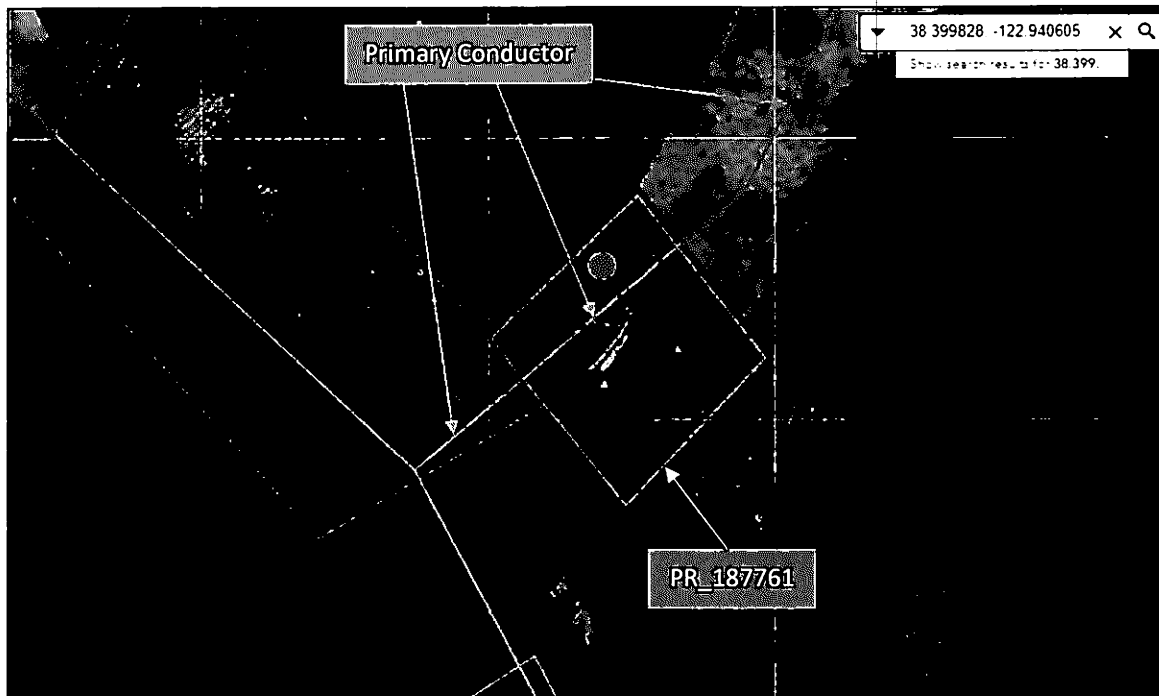
A potential hazard tree was found during a Monitor Inspection on July 11, 2019 of Project *PR_187761* on Circuit *Molino 1102*. In general terms, this circuit is located on the outskirts of the city of Sebastopol, CA, running approximately 10 miles to the west of the city. This circuit is located in/near a Tier 3 fire threat area pursuant to the ArcCollector database. The approximate position of the tree is denoted as the red circle in the second graphic below.

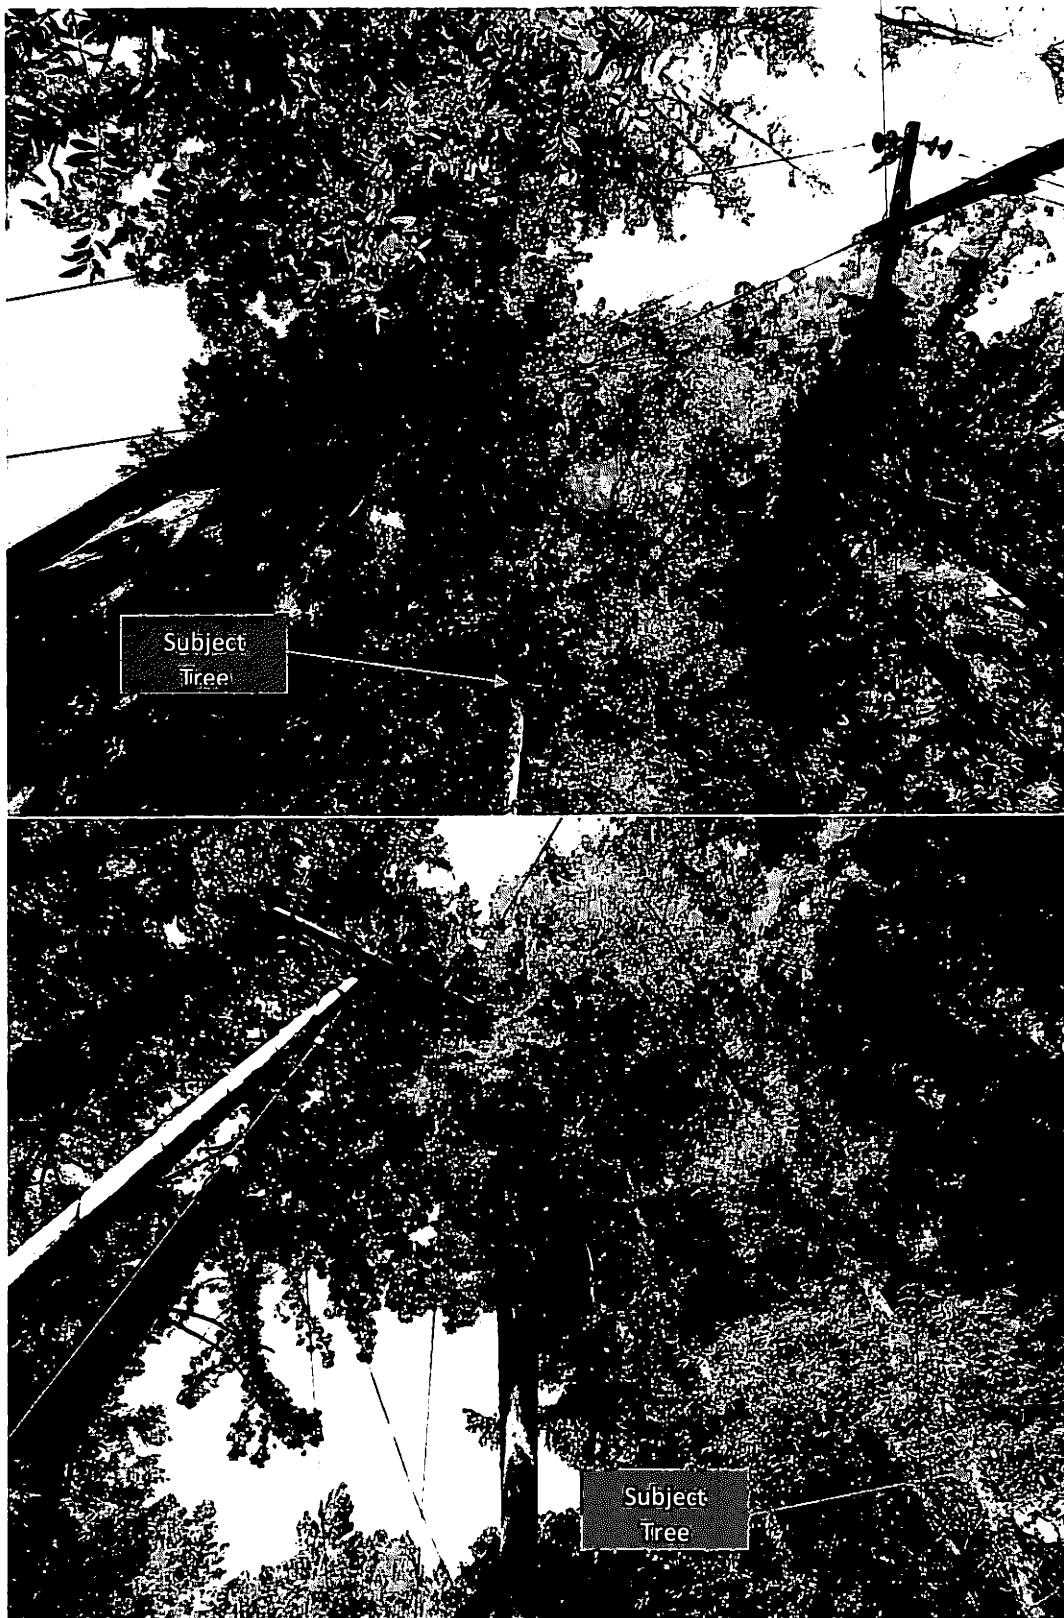
PG&E ArcCollector Project Status	Work Identified	
Monitor Team Observed Tree Work in Immediate Vicinity of Subject Tree	No	
Monitor Team Observed Recent Tree Work on Subject Tree	No	
Tree Paint or Other Markings Observed	No	
Species	California Bay	
GPS Coordinates	38.399828, -122.940605	
Approx. Distance from Primary Conductor	Trunk of tree 14 feet northwest	
Approx. Height	70 feet	
Veg Type	Potential Hazard Tree	
Monitor Arborist Comment	Observations of the tree include (a) weak multi-stemmed tree structure, (b) soil eroded around roots leading to poor anchorage, and (c) tree is overhanging line at 15 ft.

Photographs below show subject tree and proximity to the primary conductor.

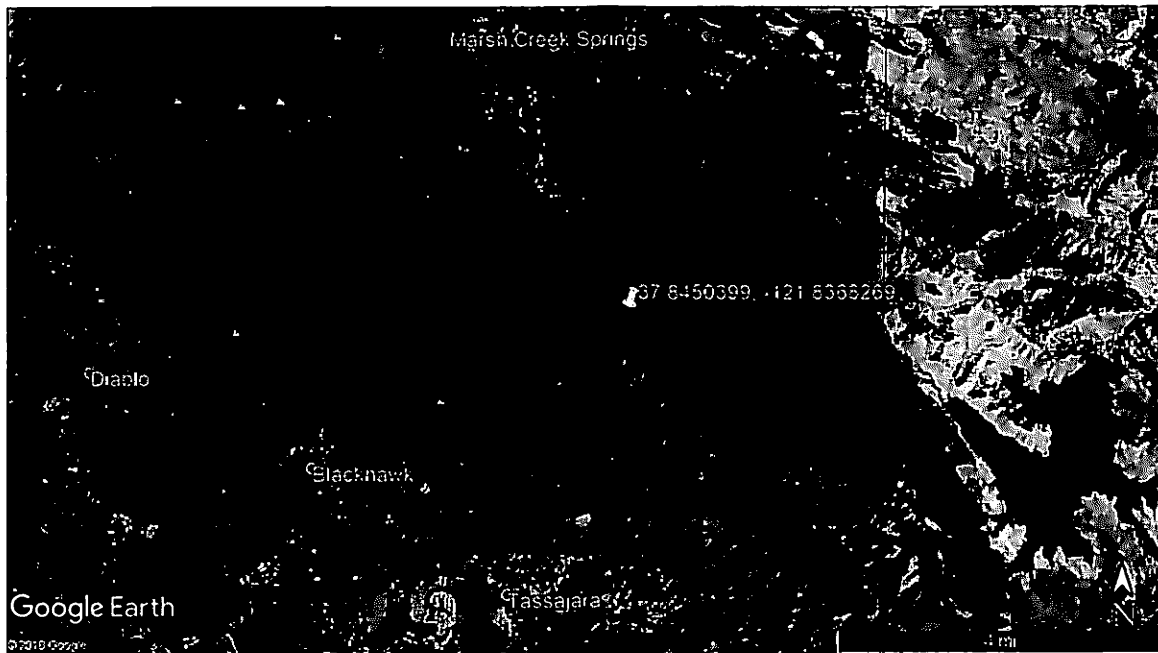
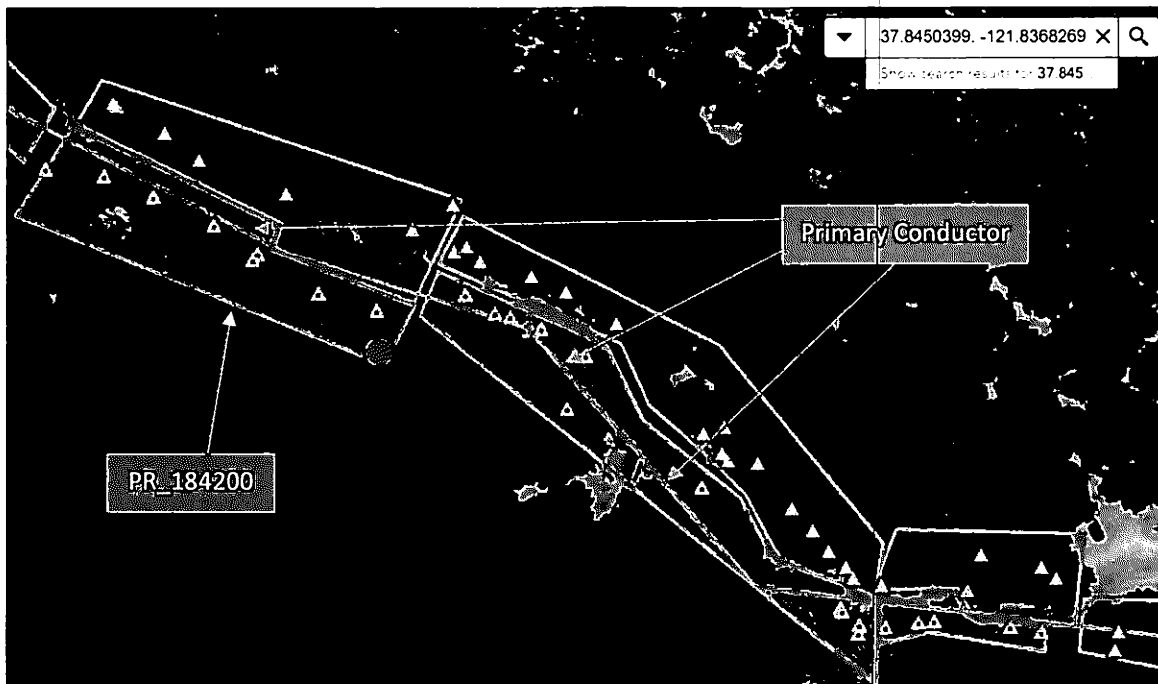
A tree with a potential overhang issue was found during a Monitor Inspection on June 6, 2019 of Project *PR_184200* on Circuit *Clayton 2212*. In general terms, this circuit is located on the outskirts of the town of Clayton, CA, running approximately 15 miles to the southeast of town. This circuit is located in/near a Tier 3 fire threat area pursuant to the ArcCollector database. The approximate position of the tree is denoted as the red circle in the second graphic below.

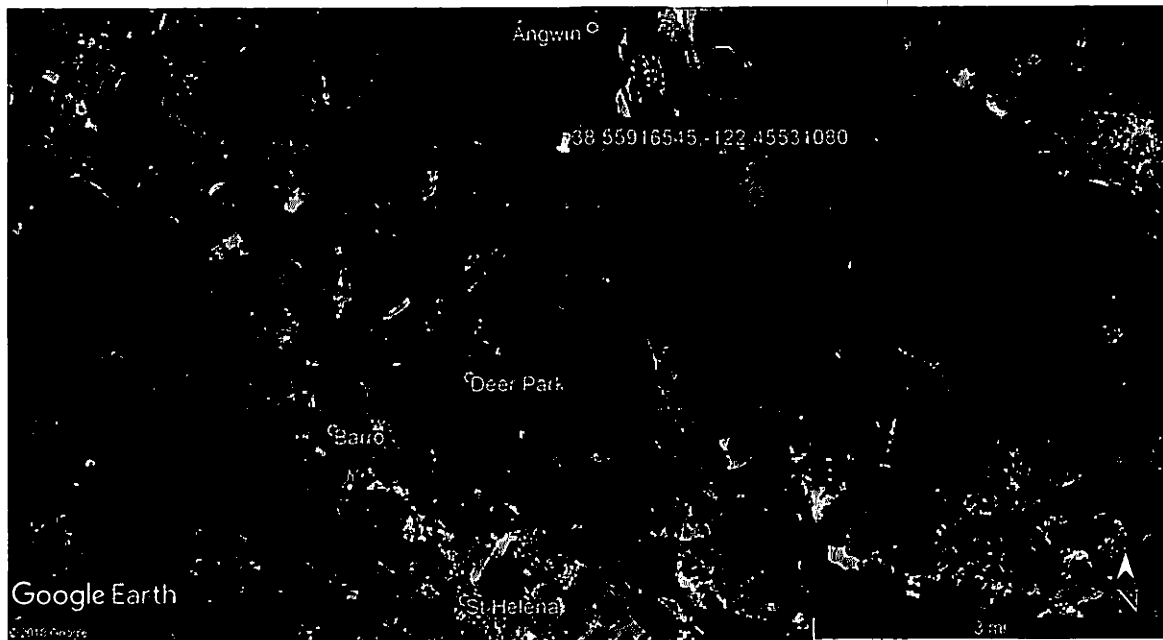
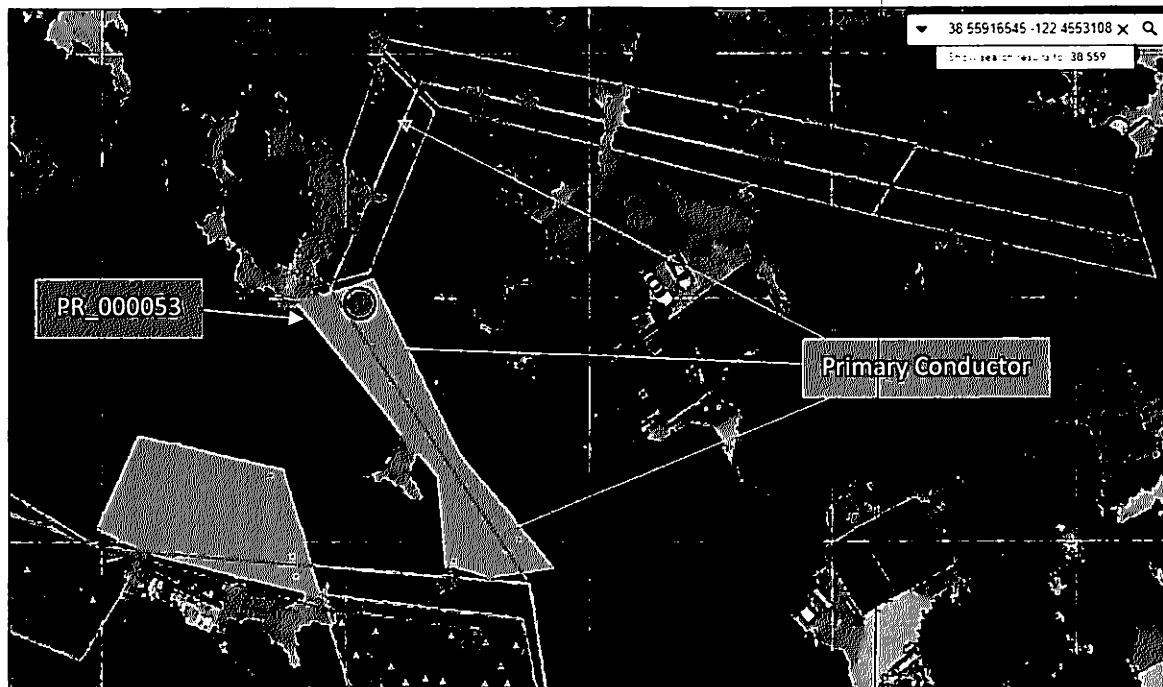
A potential overhang tree was found during a Monitor Inspection on July 3, 2019 of Project *PR_000053* on Circuit *Silverado 2104*. In general terms, this circuit is located on the outskirts of the city of St. Helena, CA, running approximately 15 miles to the north of the city. This circuit is located in/near a Tier 3 fire threat area pursuant to the ArcCollector database. The approximate position of the tree is denoted as the red circle in the second graphic below.

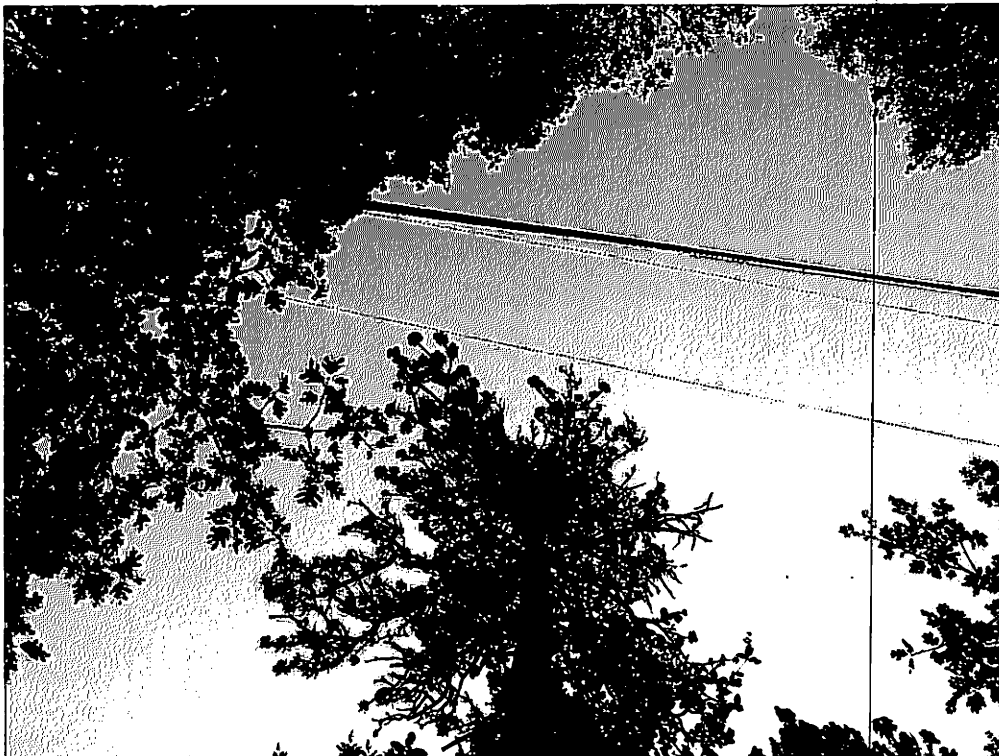
PG&E ArcCollector Project Status	Tree Work Complete	
Monitor Team Observed Tree Work in Immediate Vicinity of Subject Tree	Yes	
Monitor Team Observed Recent Tree Work on Subject Tree	Yes	
Tree Paint or Other Markings Observed	Red dot	
Species	Ponderosa Pine	
GPS Coordinates	38.55916545, -122.45531080	
Approx. Distance from Primary Conductor	Trunk of tree 18 feet east	
Approx. Height	102 feet	
Veg Type	Potential Overhang Tree	
Monitor Arborist Comment	Vegetation observed currently overhanging the 4 foot vertical plane.

Photographs below show subject tree and proximity to the primary conductor.

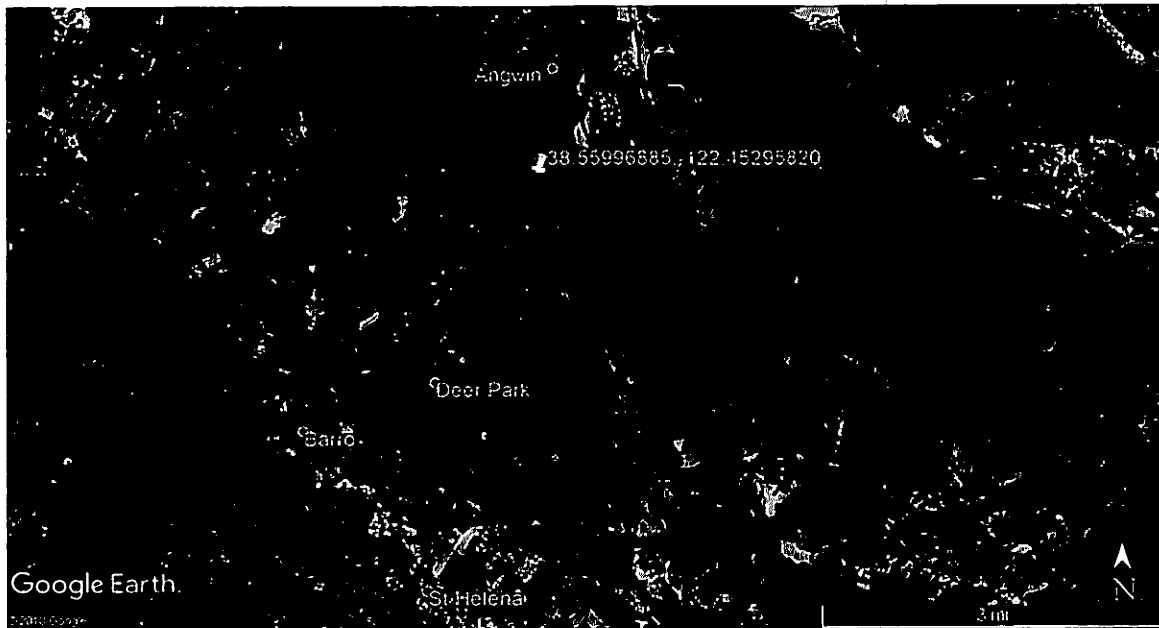
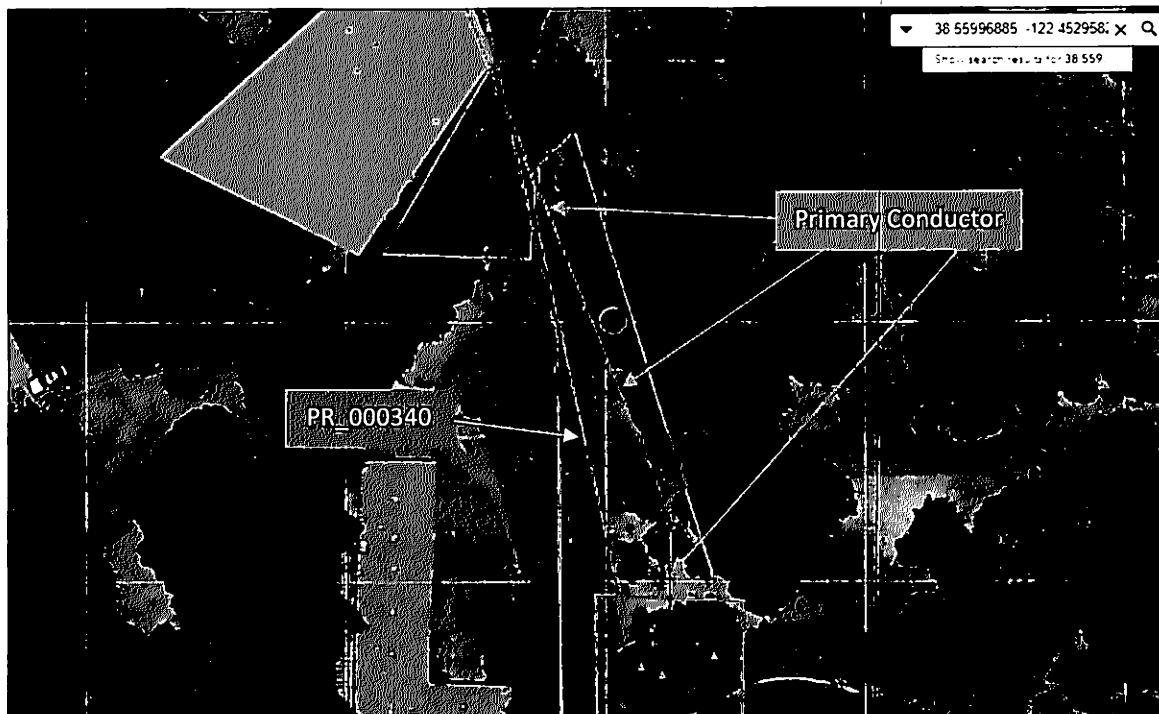
A potential overhang tree was found during a Monitor Inspection on July 3, 2019 of Project *PR_000340* on Circuit *Silverado 2104*. In general terms, this circuit is located on the outskirts of the city of St. Helena, CA, running approximately 15 miles to the north of the city. This circuit is located in/near a Tier 3 fire threat area pursuant to the ArcCollector database. The approximate position of the tree is denoted as the red circle in the second graphic below.

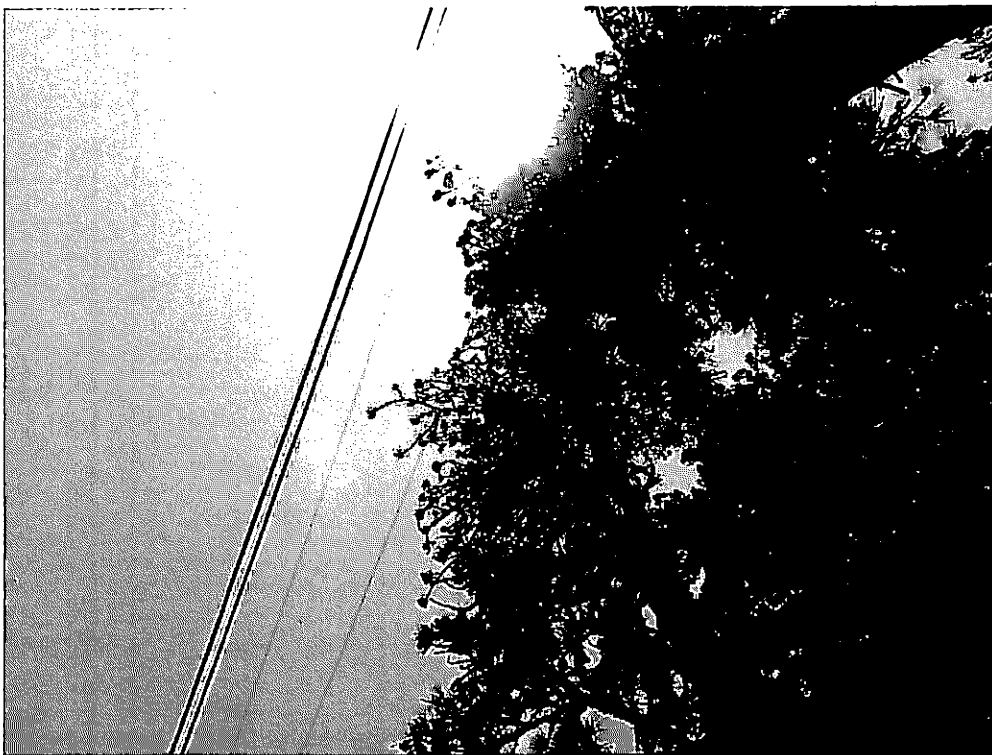
PG&E ArcCollector Project Status	Work Identified	
Monitor Team Observed Tree Work in Immediate Vicinity of Subject Tree	No	
Monitor Team Observed Recent Tree Work on Subject Tree	No	
Tree Paint or Other Markings Observed	No paint observed	
Species	Ponderosa Pine	
GPS Coordinates	38.55996885, -122.45295820	
Approx. Distance from Primary Conductor	Trunk of tree 8 feet east	
Approx. Height	115 feet	
Veg Type	Potential Overhang Tree	
Monitor Arborist Comment	Vegetation observed currently overhanging the 4 foot vertical plane, and tree not visibly marked for pruning.

Photographs below show subject tree and proximity to the primary conductor.
